Update from the Task Force

M. Garbini

EEE Task Force

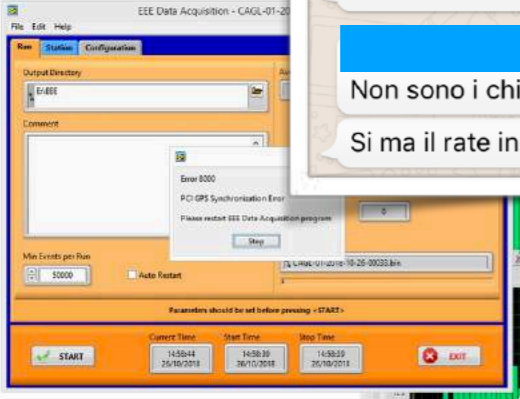
Qualcuno sa come risolvere questo errore? 14:57

su alcuni telescopi mi capita più di frequente (sale01 ad esempio) 15:02

normalmente basta ripartire e non da più errori 15:02

se si ripresenta sempre invece potresti provare a fare un reset 15:03

dal prompt dei comandi vai nella directory delle routine Spectracom 15:03

\Program Files <x86>\Spectracom\TSYNC PCI\Examples\Tsync API 15:04

lì dai SS_Reset 0 0 15:04

poi prima di ripartire controlla che abbia ripreso la connessione 15:05

SS_GetSync 0 15:05

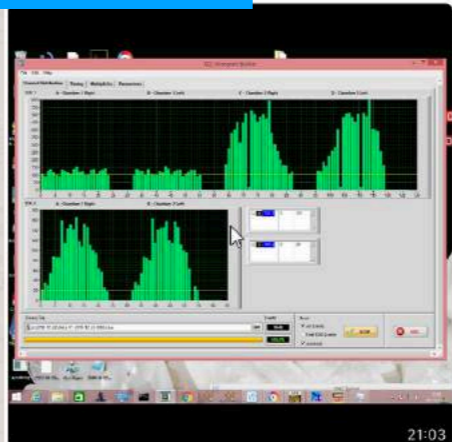
La camera 3 di sale01 improvvisamente pensa di essere la 2! Tanti auguri 21:02
