EEE Upgrade

Status Update

# MRPCs construction update

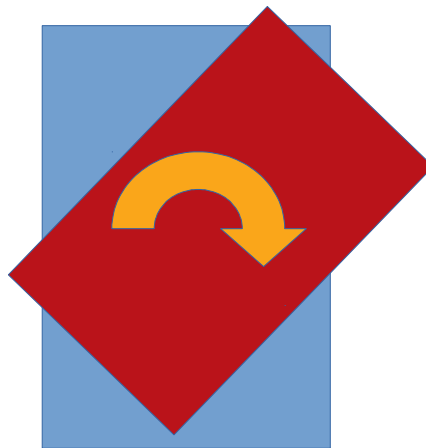
HV-

Ch 36-37-38-39  
was found to be  
correctly labeled after the rotation

This is being a rule from now on

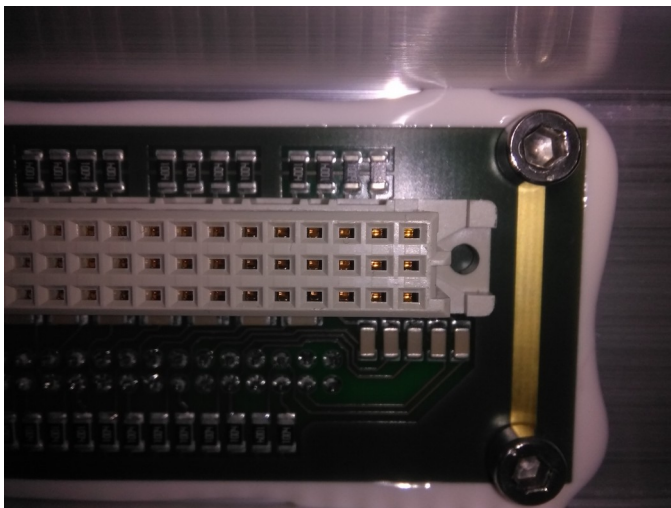
- FEA mounting on new/old interconnections

New interconnection cards are upside down mounted  
(look at the teeth)

The new cards will show  
the NUGENT connector on top

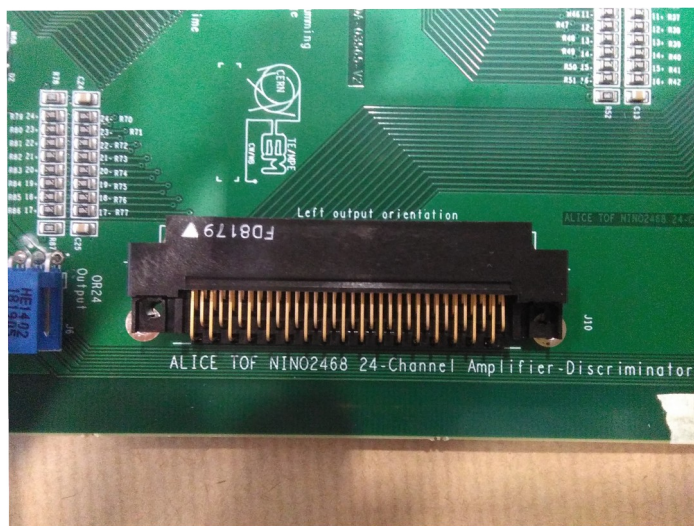
The new FEA are just LEFT type  
When inserting the card type in DAQ

- V1 if #ch < 36 or 300 um gap

-V3 if #ch >= 36

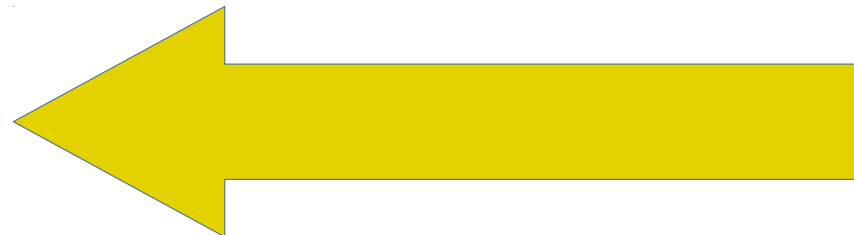
## – #42 issue

Ch42 was found with (non reproducible) strip connection

The Bossini Box test gave errors on ch #7 and #8

The connections were tested before and after interconnections with a tester

They were found working

When inserted in chassis and tested with Box, we got the error.

The chamber will stay at CERN for dismounting and ch#43 will be named 42 and delivered to Bra.

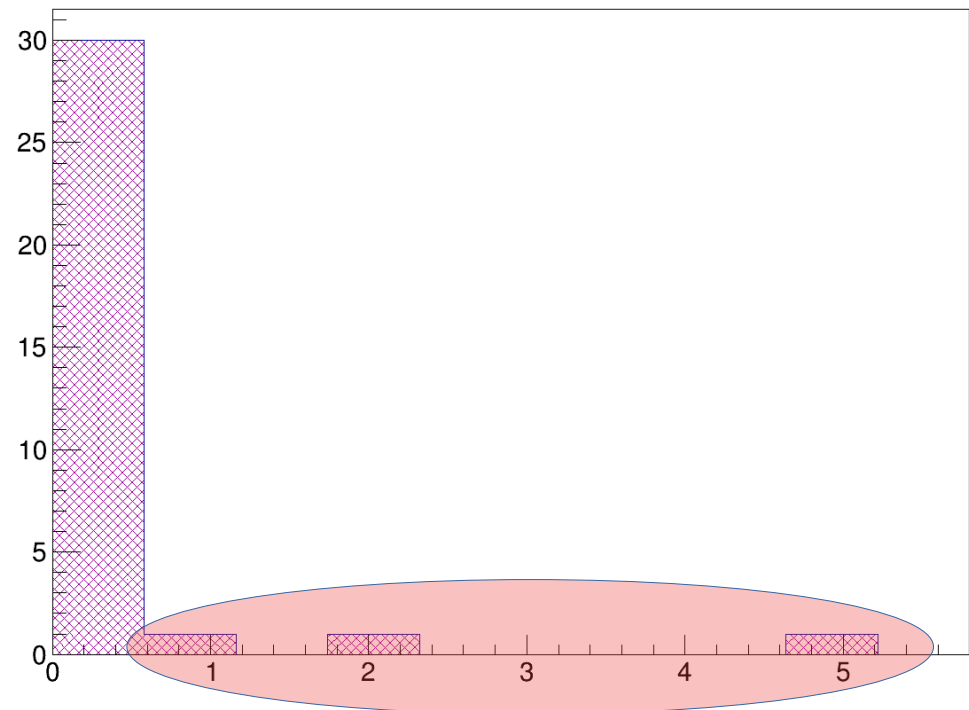
Gas tightness summary (l/h)

LAMP-01/02/03 were found highly leaking

Maria Paola did again the measurements and found

01 ---> 0,36 l/h  
02 ---> 3,92 l/h  
03 ---> 0,49 l/h

02 --> now is 0.47 l/h !

Corrado's group investigated the issue and they opened the chamber with Roman

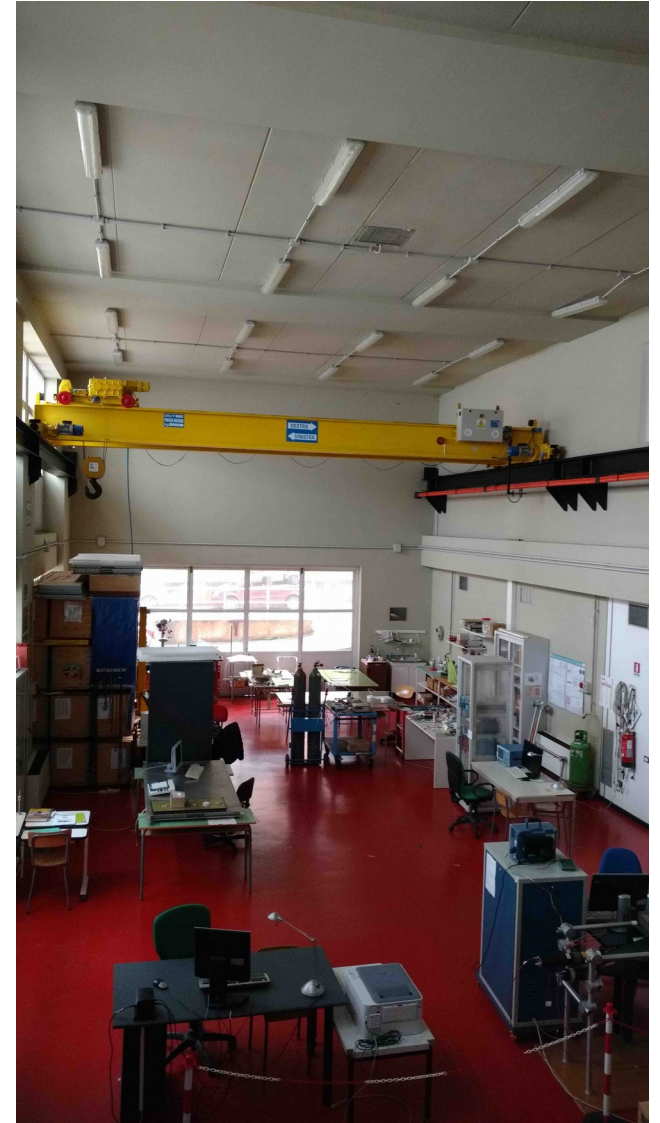
The broken CARI-01 chamber can be brought easily to Marco's lab (picture) where there is

- space available
- crane
- clean rooms

open it and test it.

→ LECCE telescope has been brought to this lab and will be mounted and put in operation as a EEE detector and a testing station
