EEE Upgrade

Status Update

# MRPCs construction & test update

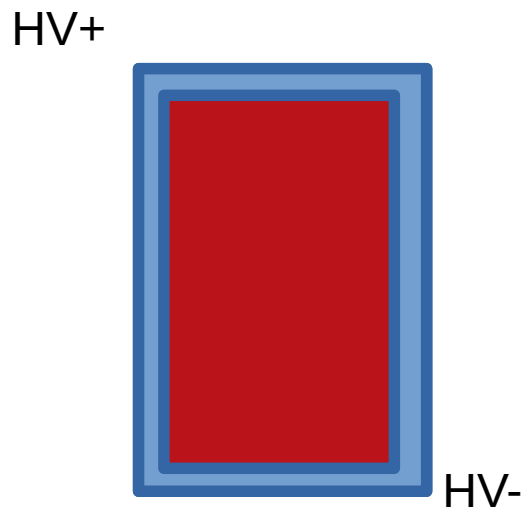
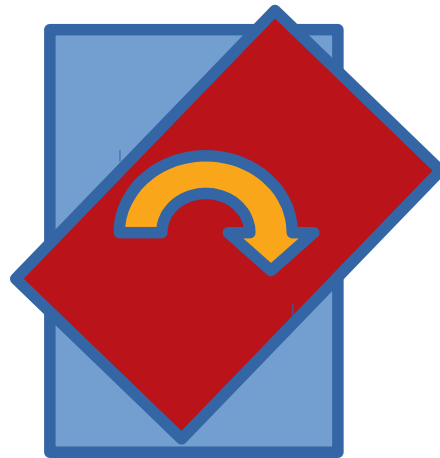
CH 36 was found with inverted HV

We found the problem was due to the new interface cards.

They are mounted 180 degrees w.r.t. previous ones.  
This correspond to and inversion of strips polarity

Ch **36-37-38-39**  
was found to be  
**correctly labeled** after the rotation

We asked to lay the chamber inside the chassis rotated  
by 180 degrees in order to solve the issue.

This worked

This is being a rule from now on

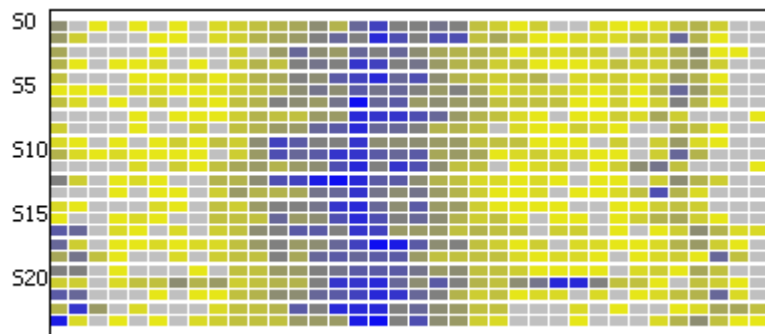
Inverted HV

CH 48 was tested in several configuration of

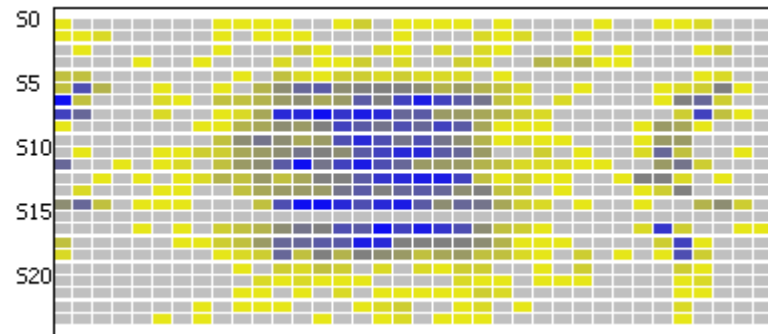
All V3

Eff~0.6

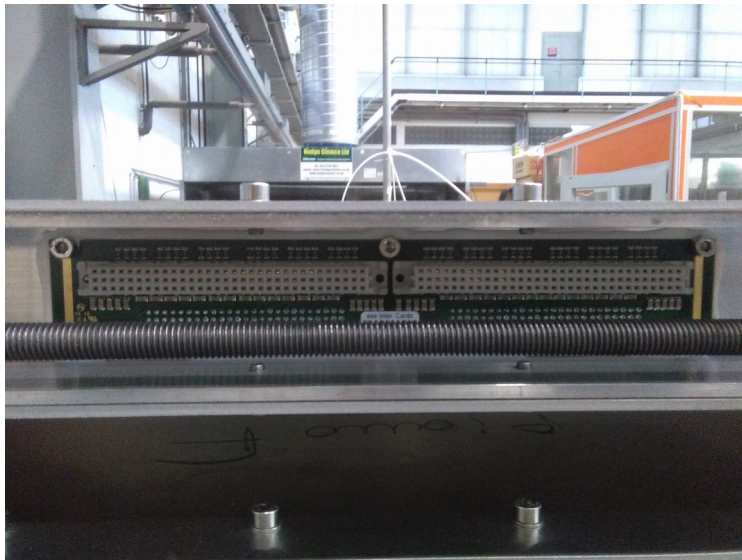
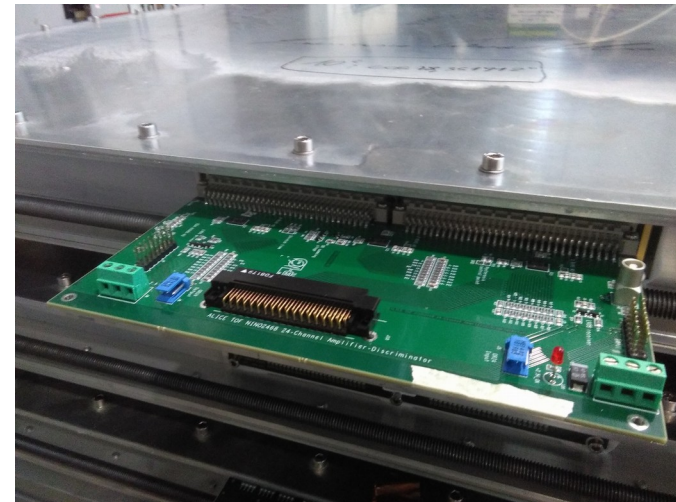
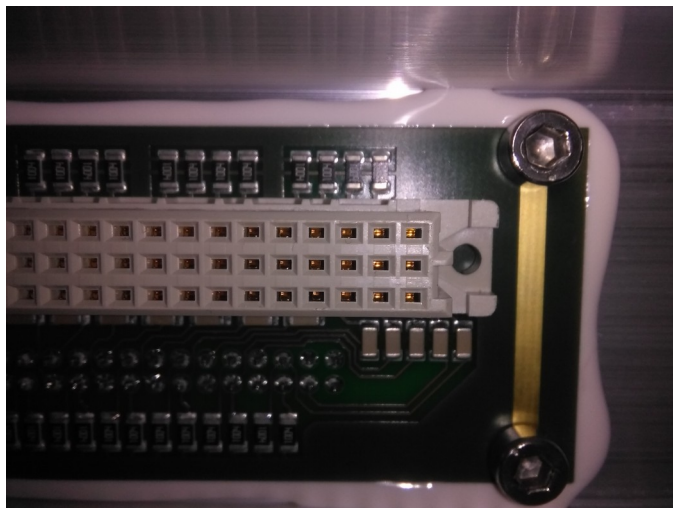
New interconnection cards are upside down mounted  
(look at the teeth)

The new cards will show  
the NUGENT connector on top

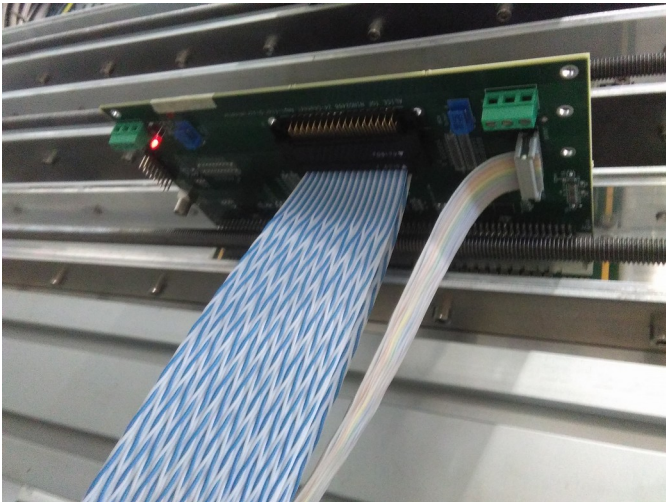
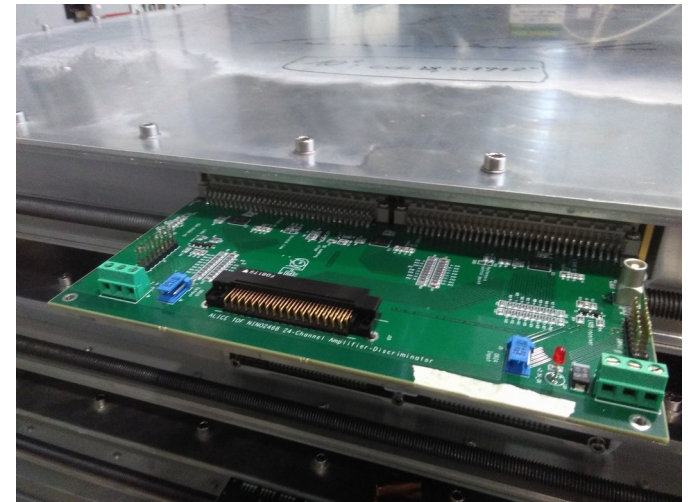
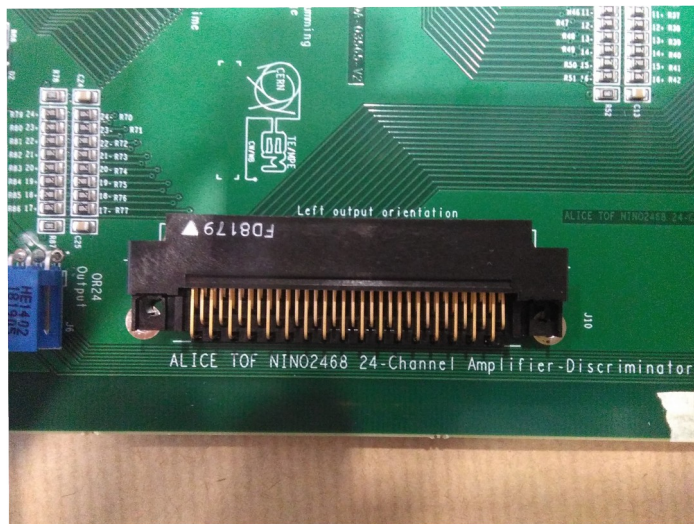
On 300 um gap MRPCS  
the nugent connector  
shows on bottom

(plus also for  
250 um #chamber < 36)

The new FEA are just LEFT type  
When inserting the card type in DAQ

- V1 if #ch < 36 or 300 um gap

-V3 if #ch >= 36

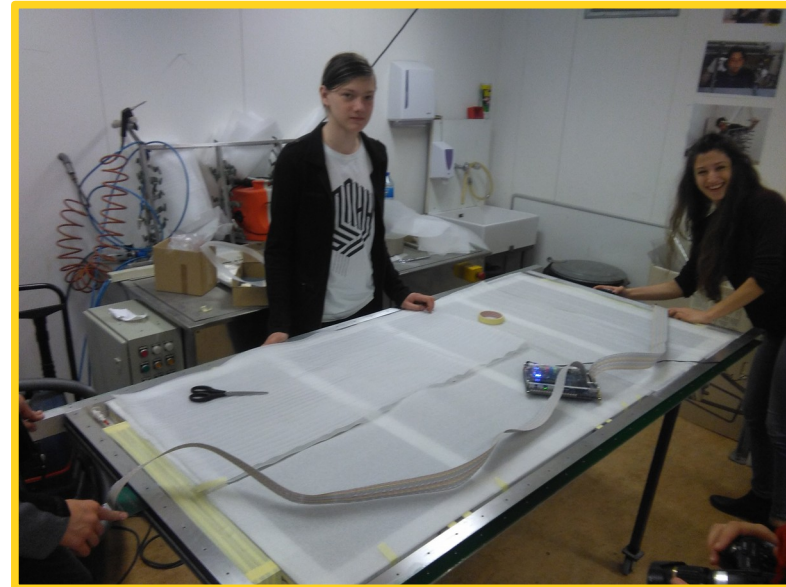
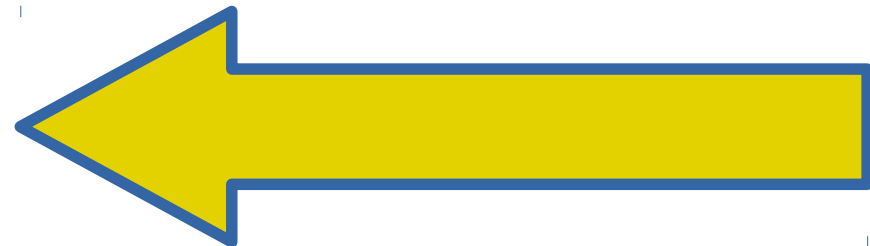
Ch42 was found with (non reproducible) strip connection

The Bossini Box test gave errors on ch #7 and #8

The connections were tested before and after interconnections with a tester

They were found working

When inserted in chassis and tested with Box, we got the error.

The chamber is dismantled and ch#43 is named 42 and delivered to Bra.

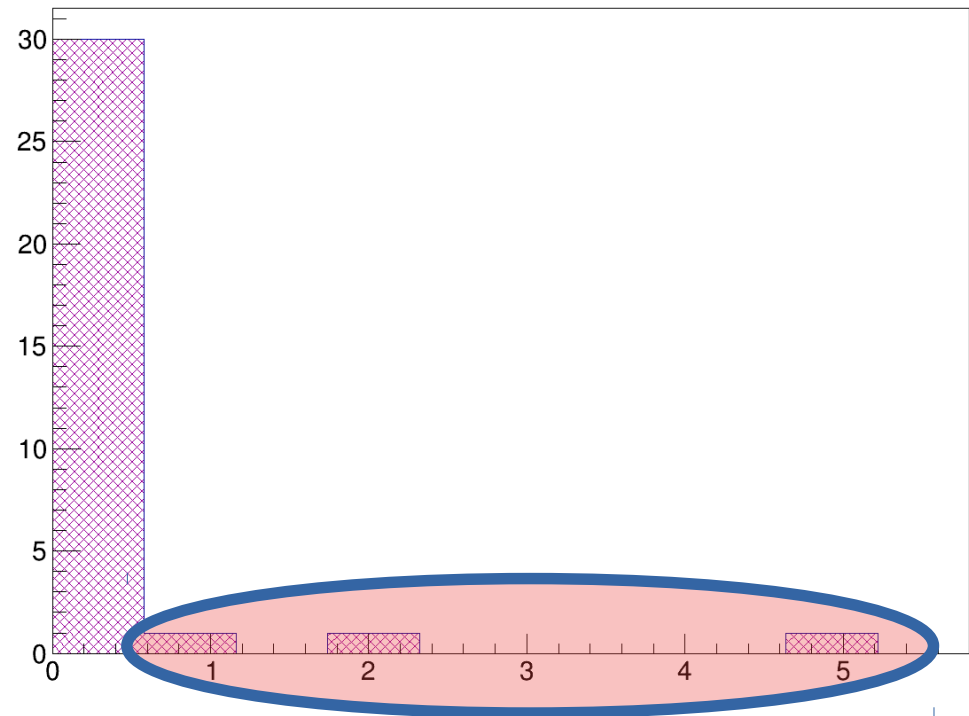
Gas tightness summary (l/h)

LAMP-01/02/03 were found highly leaking

01 ---> 0,36 l/h  
02 ---> 3,92 l/h  
03 ---> 0,49 l/h

02 --> now is 0.47 l/h !

Corrado's group investigated the issue and they opened the chamber with Roman
