# Leak Test SALE-01

## 2 Sept. 2019

# SALE-01

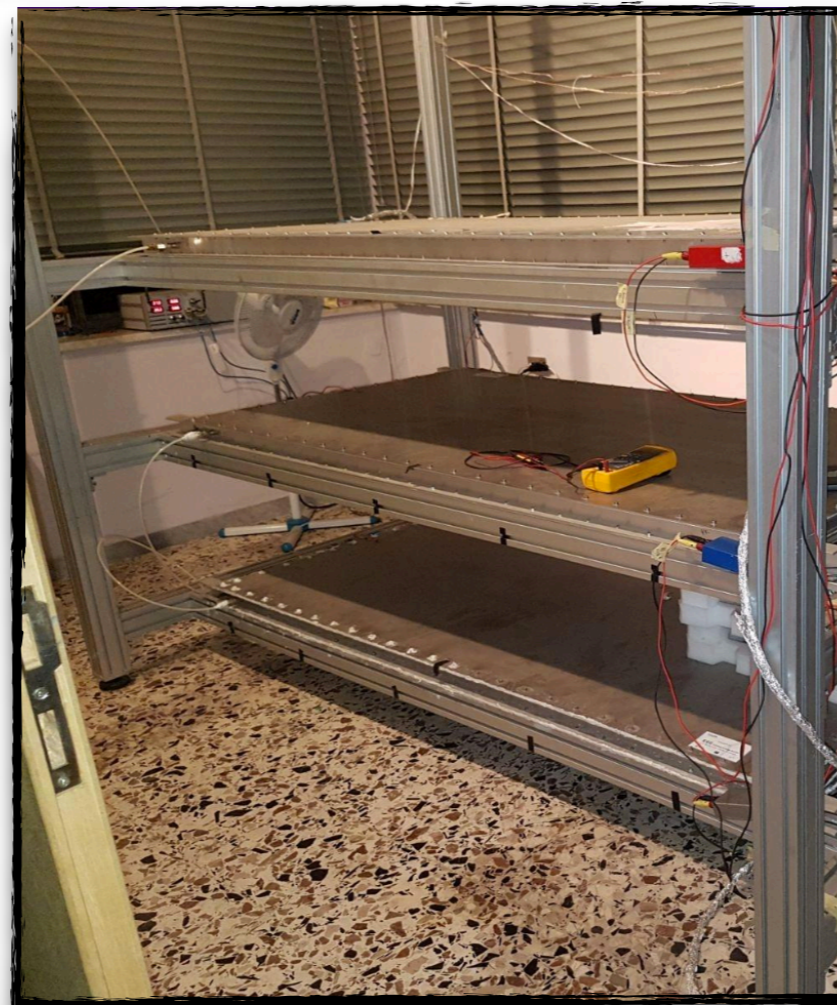
- Identified as one telescope with *unusual gas consumption*
- The plan was to measure leaks on this telescope at the latest by the beginning of September
- Measurements **performed** on September the 2nd 2019
- We followed the **procedure provided by Upgrade Team**

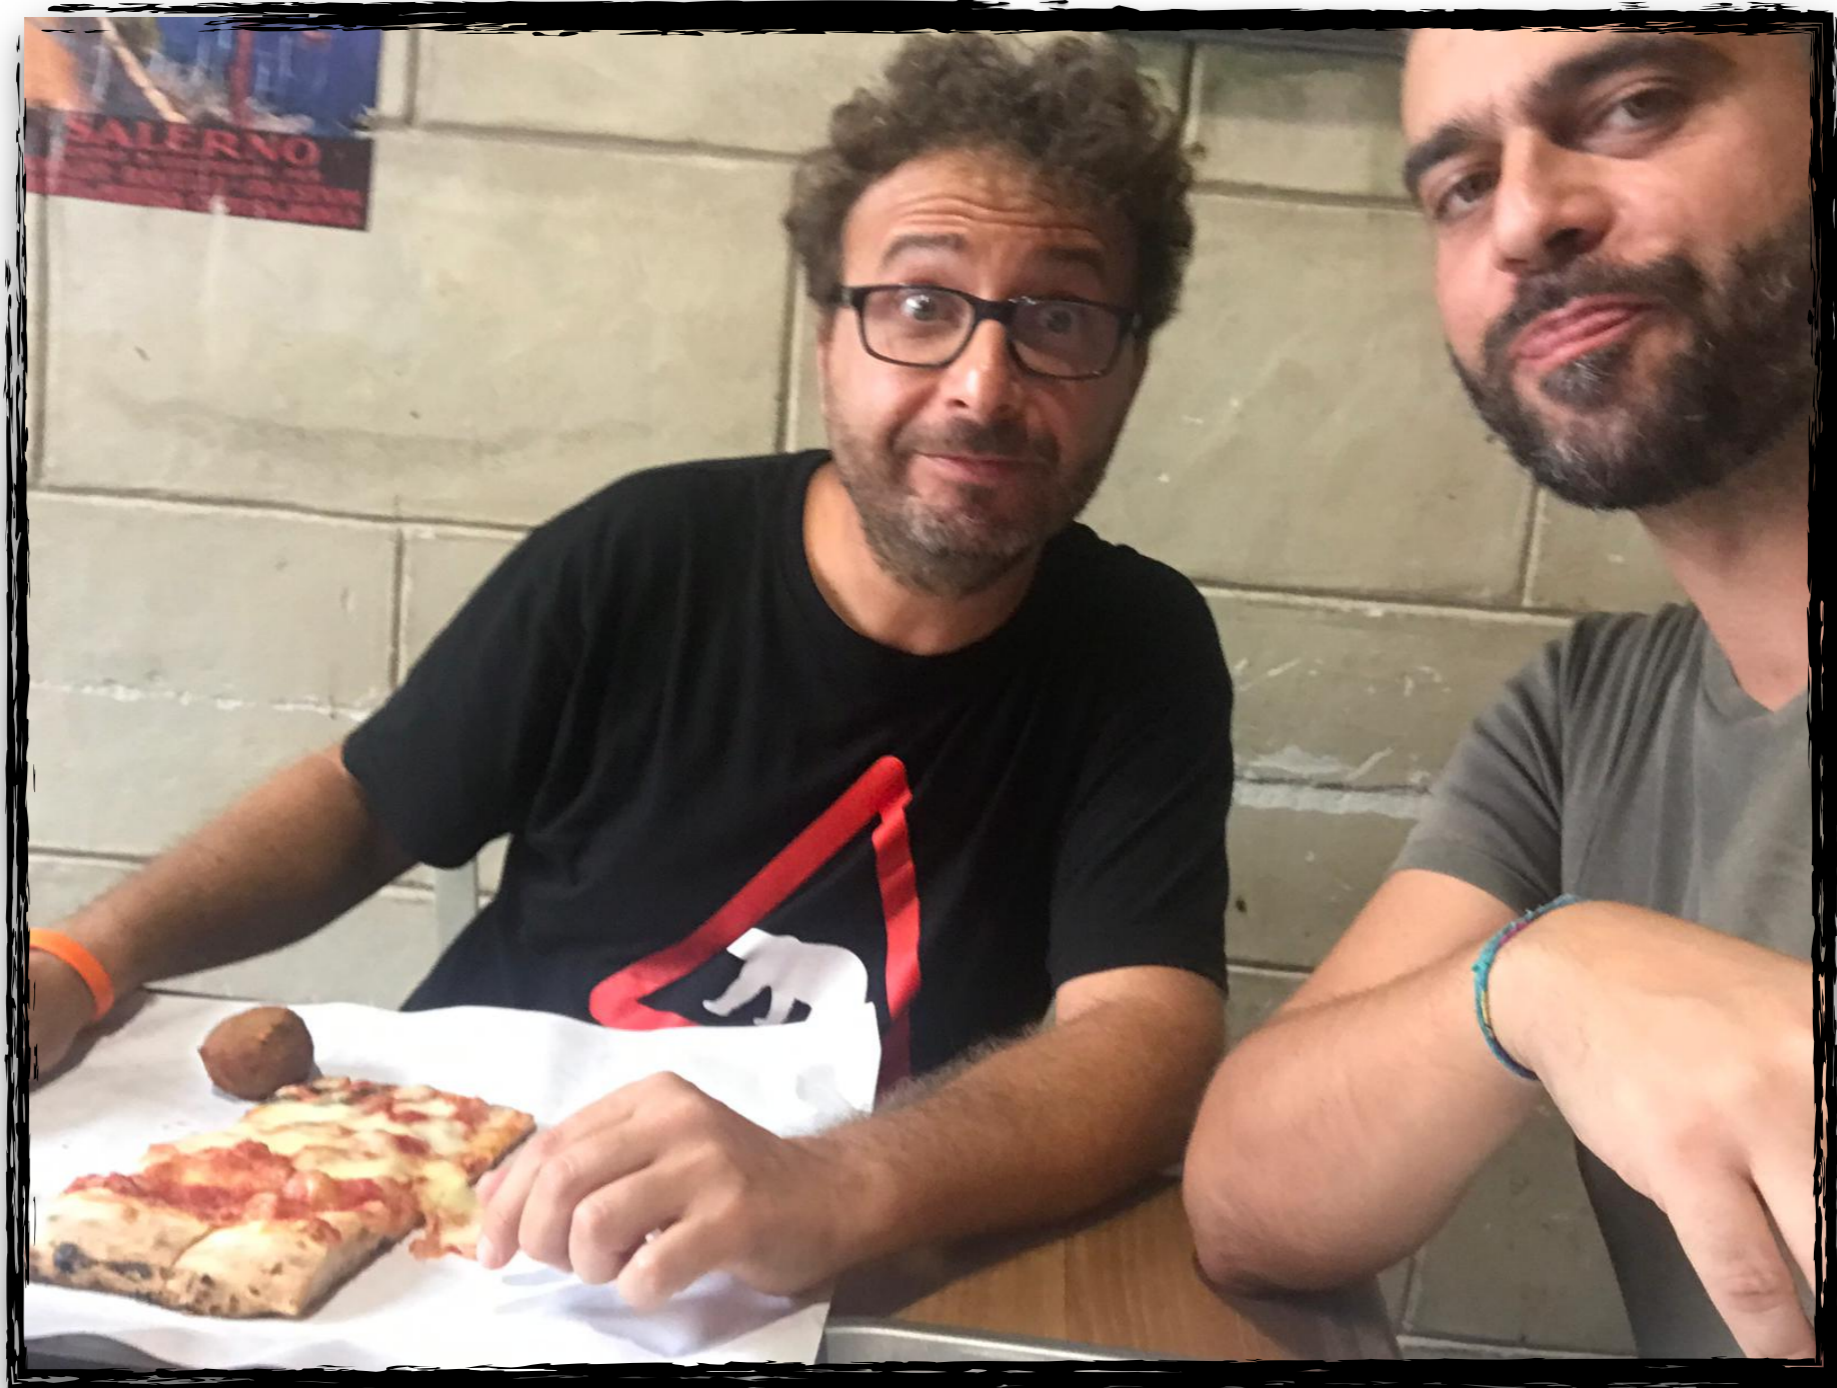
...we had a lunch break too
